# Evaluating the Effectiveness of the City of Des Moines LED and RRFB Pedestrian Crossing Treatments on Multi-Lane Roadways

**Final Report**  
**December 2012**

**Sponsored by**  
Iowa Department of Transportation  
(InTrans Project 10-387)

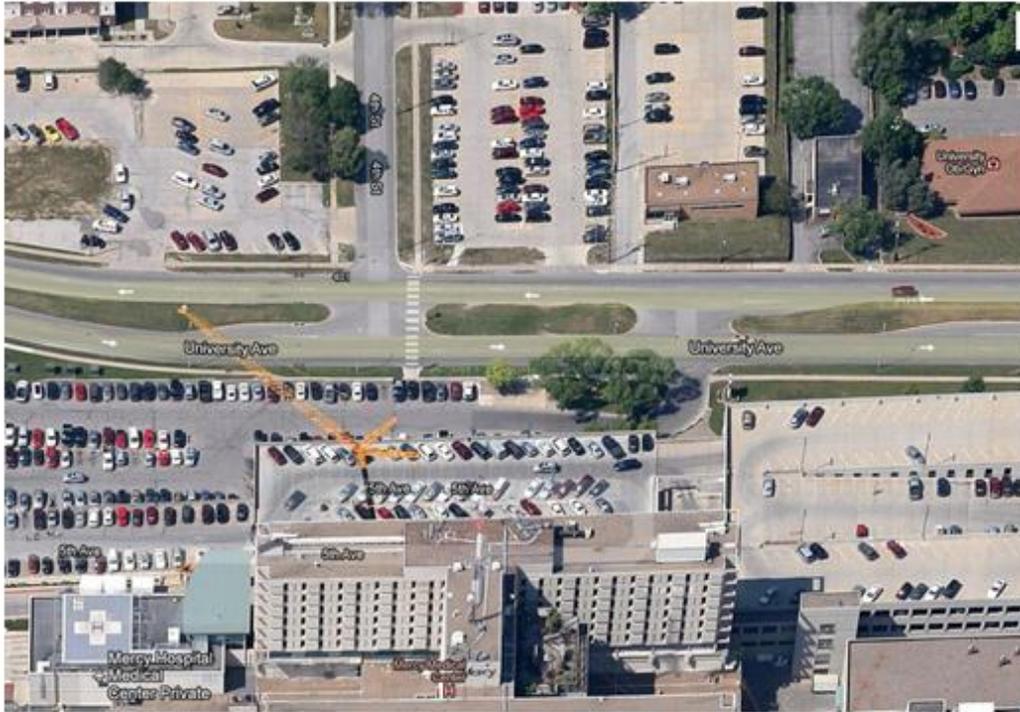
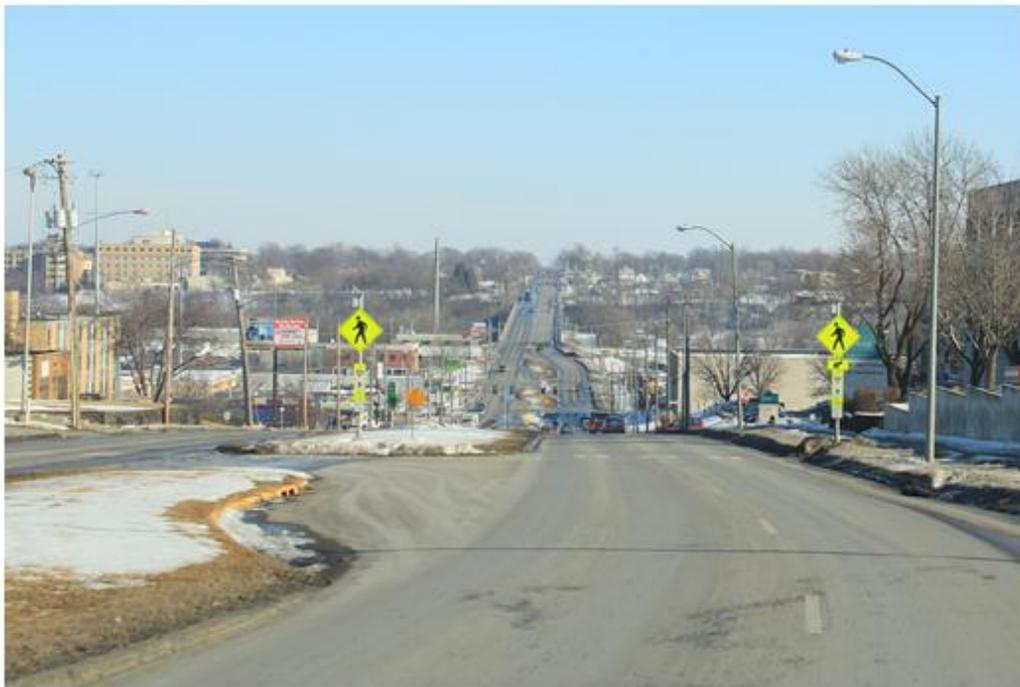
**Figure 2. University Avenue crossing (aerial view top, eastbound view bottom)**

University Avenue is a four-lane divided arterial, which has a speed limit of 35 mph. Average daily traffic (ADT) was 17,600 vehicles per day (vpd) in 2008. The roadway is on a grade (downhill for eastbound motorists), lighted, has a wide raised grass median, and has two lanes of travel for each direction. Figure 2 provides an aerial and roadway view of this crossing location.

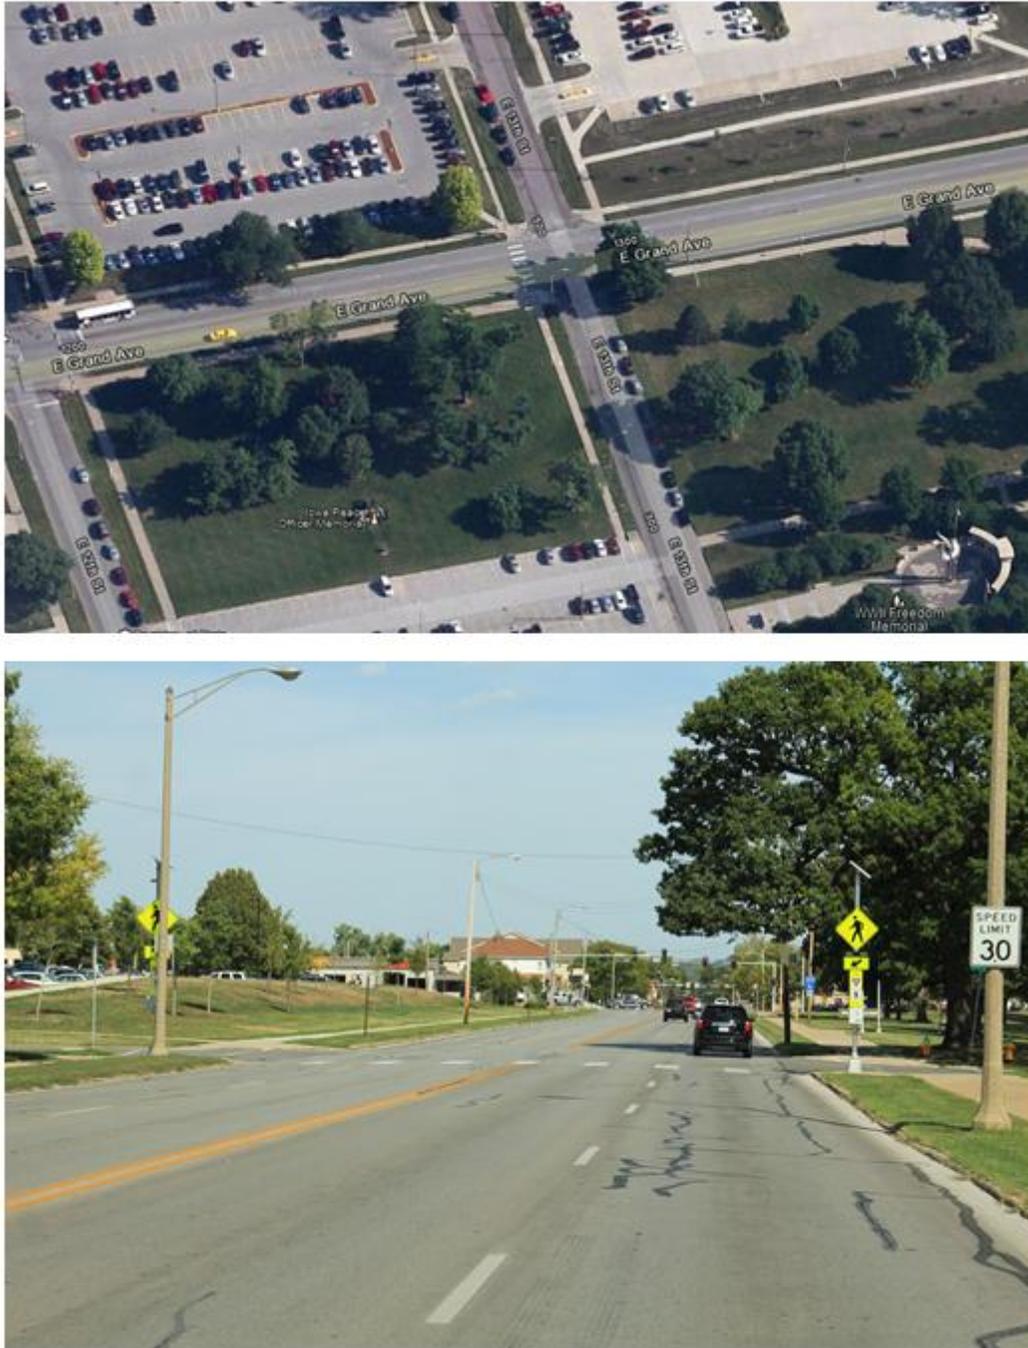
**Figure 3. East Grand Avenue crossing (aerial view top, eastbound view bottom)**

East Grand Avenue is a four-lane divided arterial, which has a 30 mph speed limit. ADT was 9,400 vpd in 2008. The roadway is level, lighted, undivided, and provides two lanes of travel for each direction. Figure 3 provides an aerial and roadway view of this crossing location.
